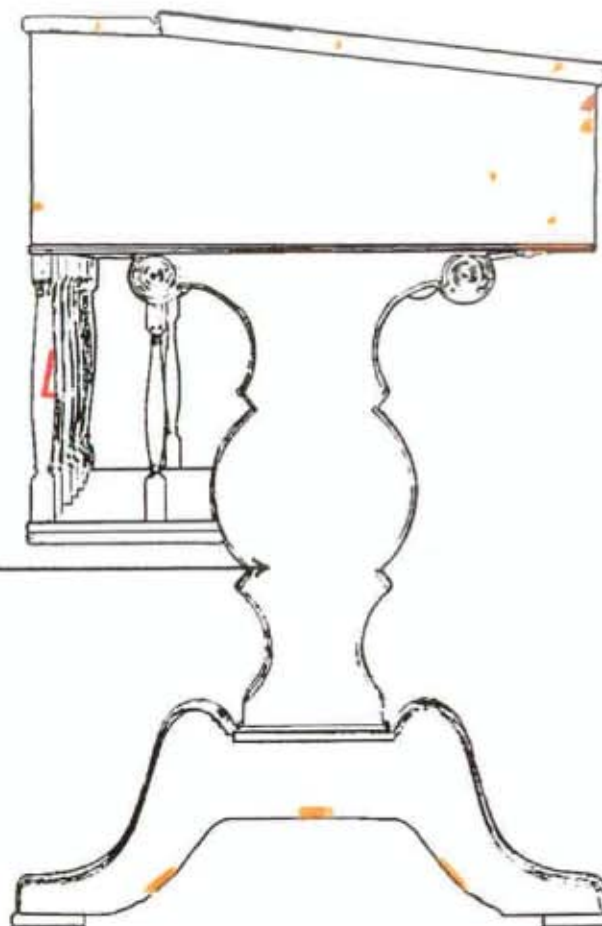
Left Side

*Note: No cross-banding*

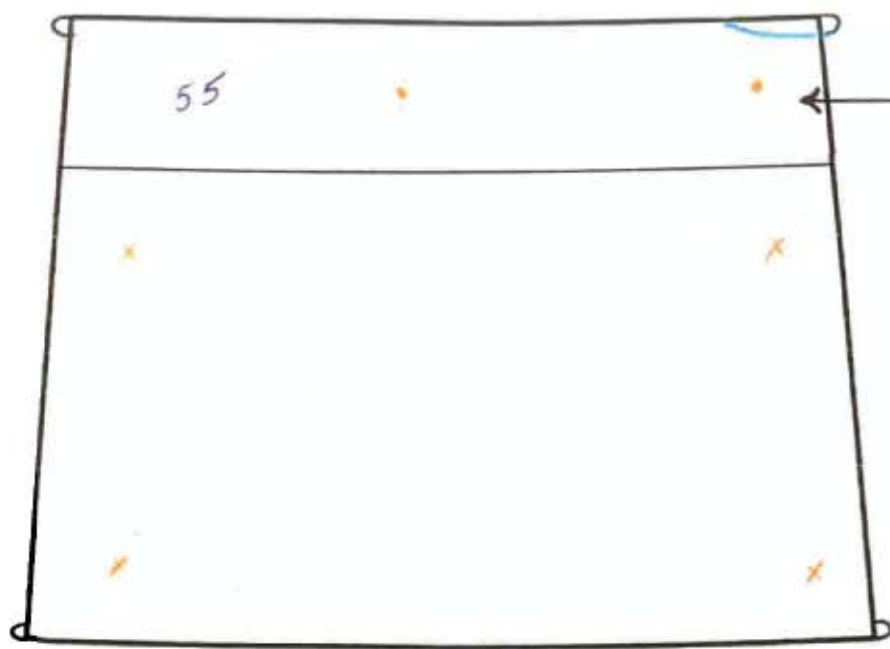
Top

Note: no opening for inkwell
